**STRATEGY FOR IMPROVING INTERSECTION
SAFETY:
IN-SERVICE SAFETY REVIEWS FOR FIVE
INTERSECTIONS**

KAMLOOPS, BRITISH COLUMBIA

November 2003

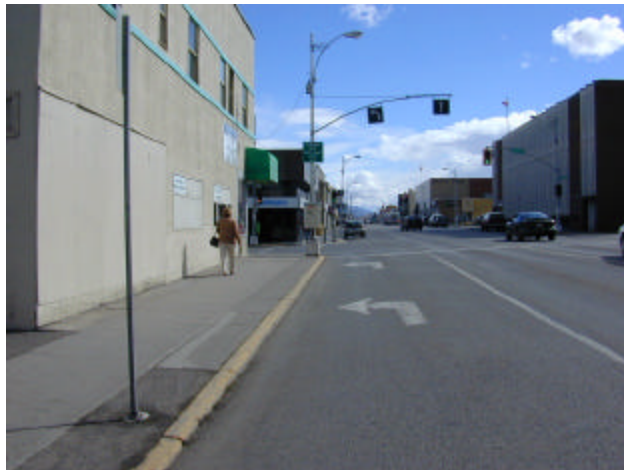
Various factors contributed to reduce the conspicuous-ness of traffic signals. At downtown intersections, only one primary signal head was provided for three lanes of traffic. The primary signal head would be outside the cone of vision for drivers in the curb lane.

FIGURE G-1 PRIMARY SIGNAL HEAD OUTSIDE OF DRIVER'S CONE OF VISION (Also note how secondary signal head blends into buildings in the background.)

At many locations, traffic signals had 300 millimetre red indicators, but 200 millimetre indicators for the amber and green lenses. On some secondary signal heads, all of the lenses were 200 millimetres, and backplates were generally not provided. On a background of dark foliage, secondary signal heads without backplates may be difficult to see. With less conspicuous signal heads, drivers may notice the indications late, possibly contributing to rear-end, angle and left-turn opposing collisions.

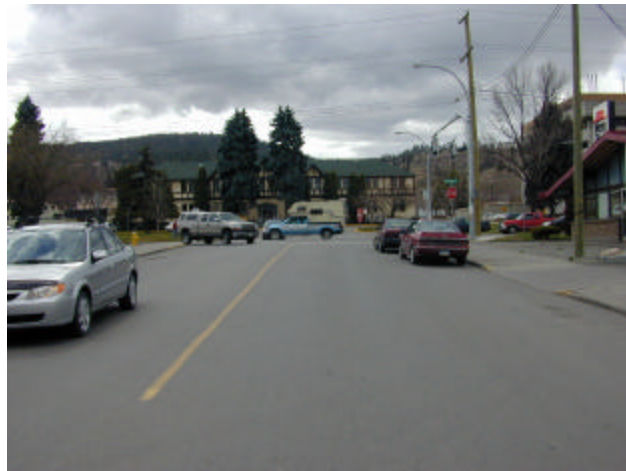
Wide approach lanes, and the presence of parked vehicles (especially large vehicles such as mini-vans or trucks) may make the STOP sign less conspicuous. Drivers may notice the STOP sign late, or not at all, possibly contributing to angle and rear-end collisions. Wide lanes can also lead to lane use confusion and sideswipe collisions.

FIGURE G-2 STOP SIGN IS OUTSIDE THE DRIVER'S PRIMARY CONE OF VISION

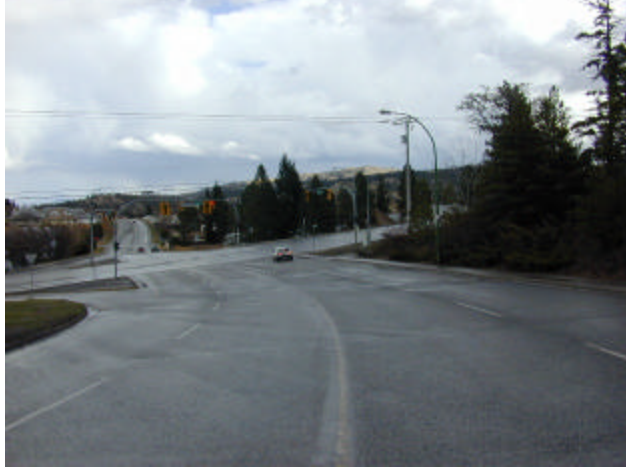
Because of the topography of the Kamloops area, numerous intersections had vertical curves and horizontal curves on the intersection approaches. Such features can reduce the visibility of the intersection ahead, reduce crossing sight distance, or make traffic control devices less conspicuous. At other locations, roadside vegetation further reduced stopping or crossing sight distance. Drivers may not anticipate the need to stop, or may stop late, contributing to rear-end and angle collisions.

**FIGURE G-3 CURVED APPROACH
MEANS THAT SIGNAL HEADS ARE TO
THE DRIVER'S LEFT, BLOCKED BY
OTHER SIGNALS AND LESS VISIBLE
UNTIL THE LAST MINUTE**

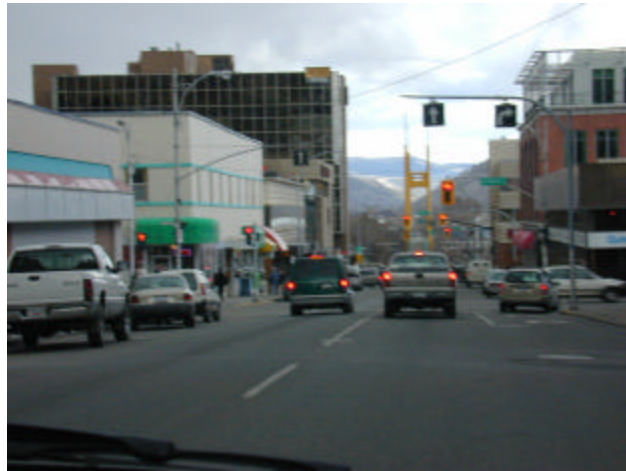
These issues include: high pedestrian demand and narrow sidewalks; clearance intervals; lack of building setback reduces crossing sight distance and pedestrian visibility; visual clutter reducing signal visibility, parking close to the intersection. These issues were all discussed in detail in SECTION C.

FIGURE G-4 TYPICAL DOWNTOWN INTERSECTION WITH VISUAL CLUTTER, REDUCED CROSSING SIGHT DISTANCE, AS WELL AS PEDESTRIAN AND PARKING ACTIVITY

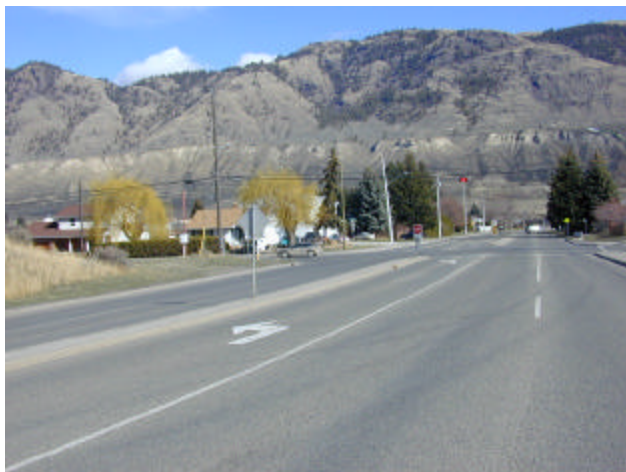
A high number of approach lanes, unbalanced traffic volumes, and presence of pedestrians can create confusion about right-of-way at a four-way STOP. This causes driver impatience and erratic turning manoeuvres, and can potentially contribute to angle, left-turn crossing and rear-end collisions.

FIGURE G-5 MULTIPLE APPROACH LANES MEAN THAT DRIVERS MAY HAVE DIFFICULTY REMEMBERING WHO HAS THE RIGHT-OF-WAY

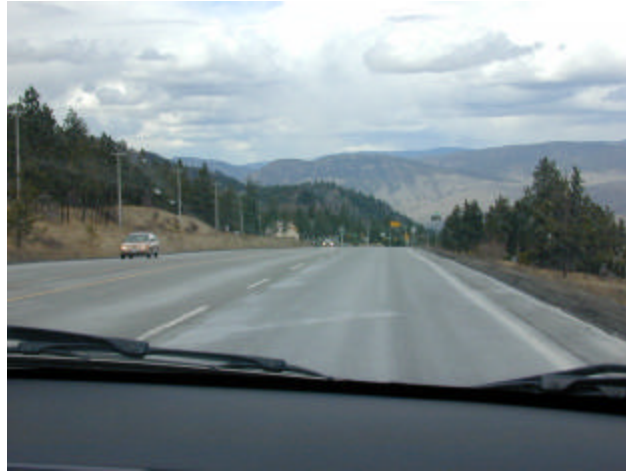
Long distances between intersections, and accesses, downhill grades, one-way streets and wide cross-sections can all provide drivers with the opportunity to pick up speed on their approach to intersections, possibly contributing to off-road and rear-end collisions.

**FIGURE G-6 INTERSECTION SPACING
MAY CONTRIBUTE TO HIGHER SPEEDS**
