# Big Beams and Big Dreams

Anyone who has walked by Westsyde Pool and Fitness Centre lately may have noticed things are looking a little bit different. On Friday, October 14, the pool's roof was lifted off, meaning that demolition is almost complete and reconstruction is underway.

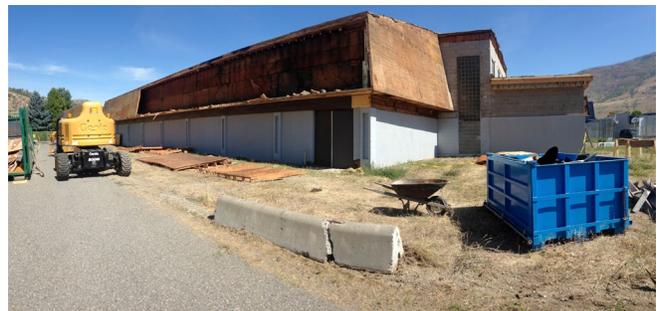
**Above:** The original roof of the Westsyde Pool, prior to its removal on October 14, 2016.

Prior to their removal, the glulam beams supported the pool roof. Over time, the ends of the beams had started to rot, compromising their structural integrity.

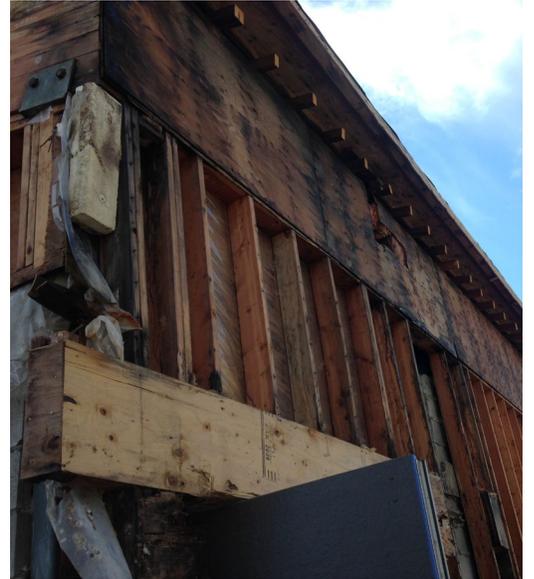
**Above:** Glulams in the main structure.

From the start of this project in April 2016, the City has been looking for opportunities to make sustainable choices and salvage reusable materials. When the pool's roof was removed and it was determined that nine of the 70 ft. glulam (glue laminated timber) beams were salvageable, the decision to repurpose the beams was an easy one.

Glulam beams are both strong and durable and can be used for everything from bridges to open ceilings. They are found in residential and commercial builds. While they have the potential to last hundreds of years, they can also be impacted by their environment. In the case of the Westsyde Pool, the beams

were exposed to a damp environment for over 40 years. Consequently, they started to break down.

Kachel emphasized that the rotting that had occurred was mostly contained to the ends of the beams. This means the majority of the beams can be salvaged and repurposed.

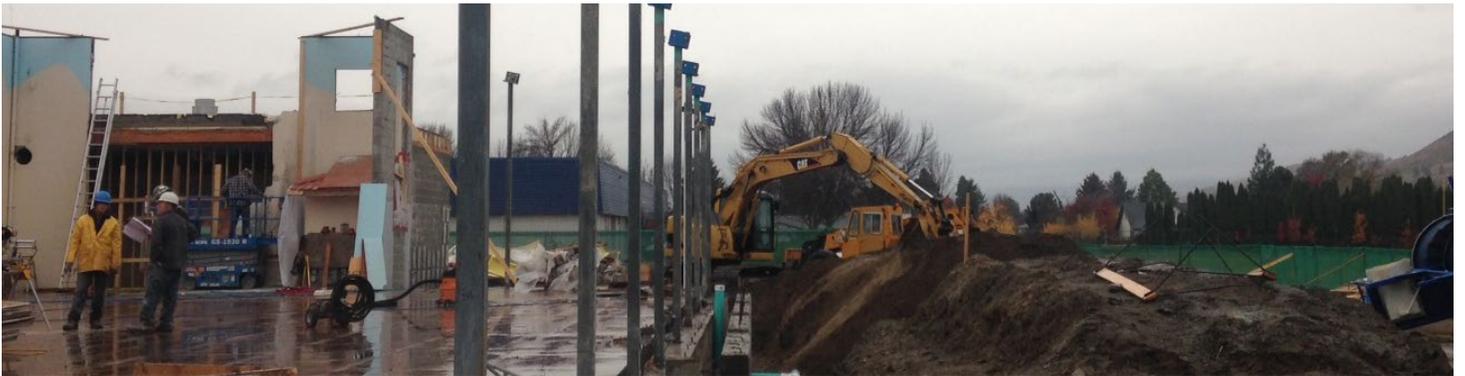
**Above:** The building after demolition.

Because the beams played such an important role in the structure of the building, their removal required the complete demolition of the pool's supporting structure.
